# LOT 69 EASTMANS GREEN SUBDIVISION NEWSTEAD

## GEOTECHNICAL SUMMARY

## SITE (“SOIL TEST”) CLASSIFICATION

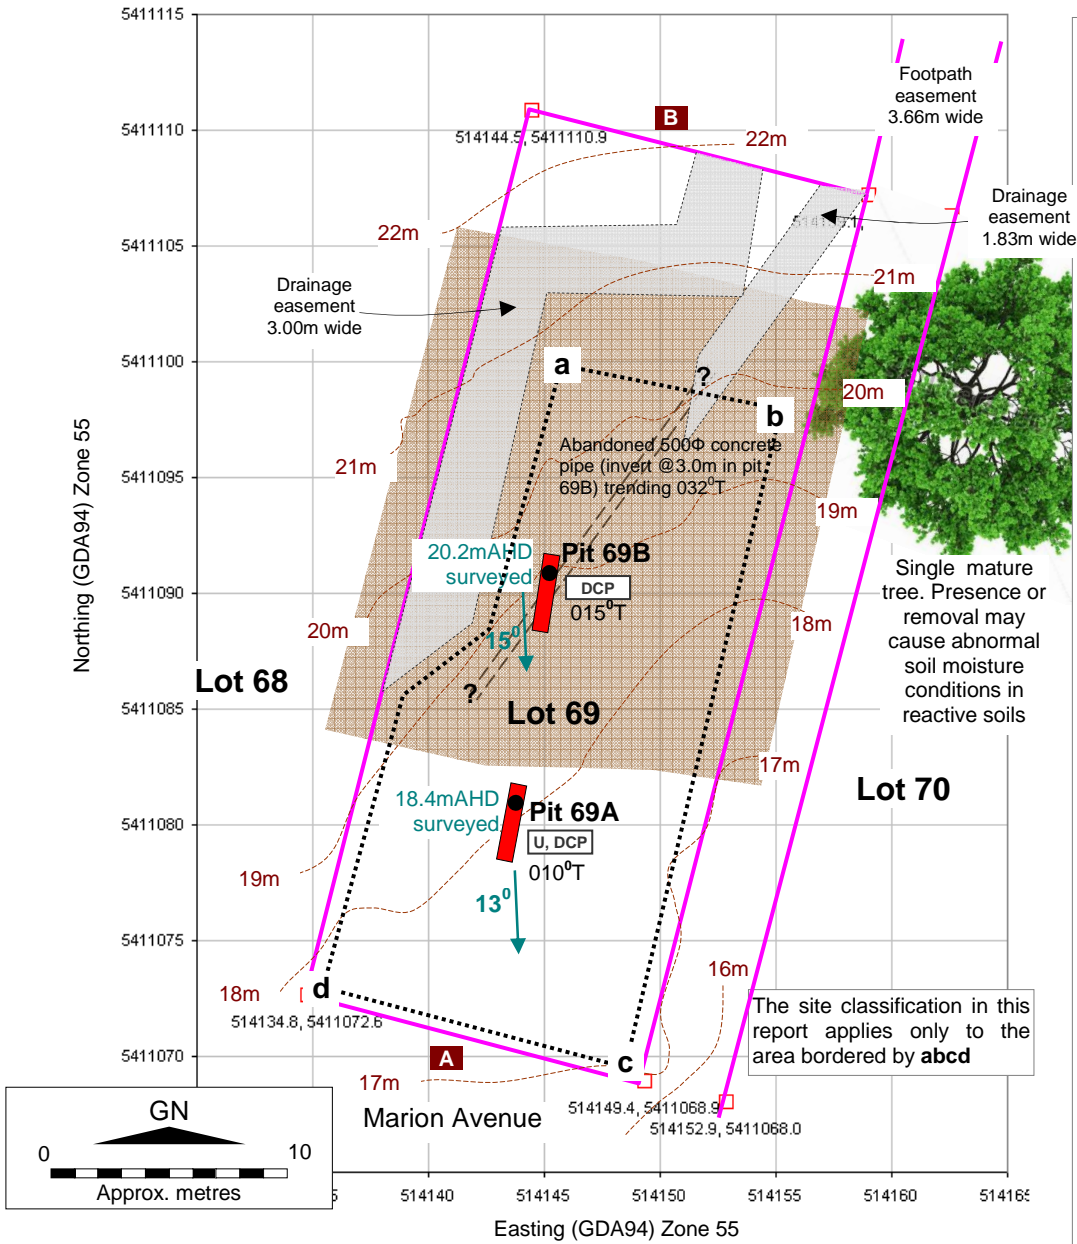
## Site plan and cross section

Excavated backfill in test pits is uncontrolled, low strength and prone to settlement. Designers and builders must take account of test pit locations in footing design and placement.

Areas inferred to comprise controlled fill other than sand and deeper than 0.4m, and/or uncontrolled fill deeper than 0.8m for sand and 0.4m for material other than sand,

Purchasers of lots are advised to commission a survey check of lot dimensions and a detail survey.

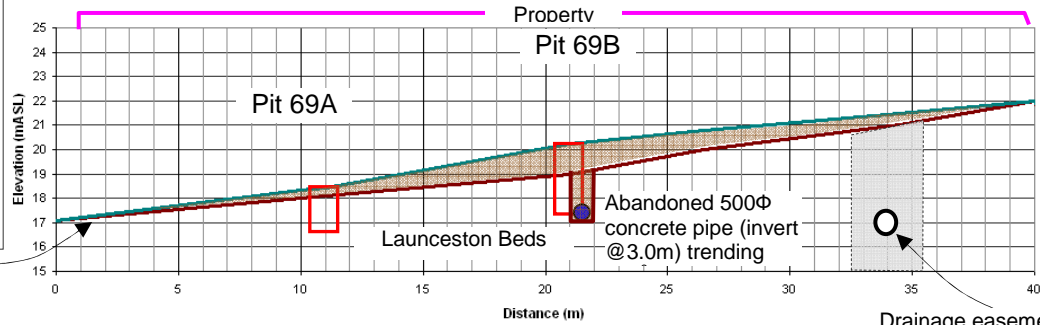
Lot 69 Cross section A – B (natural scale)

Inferred fill deeper than 0.8m for sand and 0.4m for material other than sand. Thickness shown here is based on site surface observation, exposures in test pits, and the 1m 2008 LIDAR contours. Ground surface was not surveyed other than at pits 69A and 69B.

Drainage easement with sewer pipe (diam. and depth uncertain)

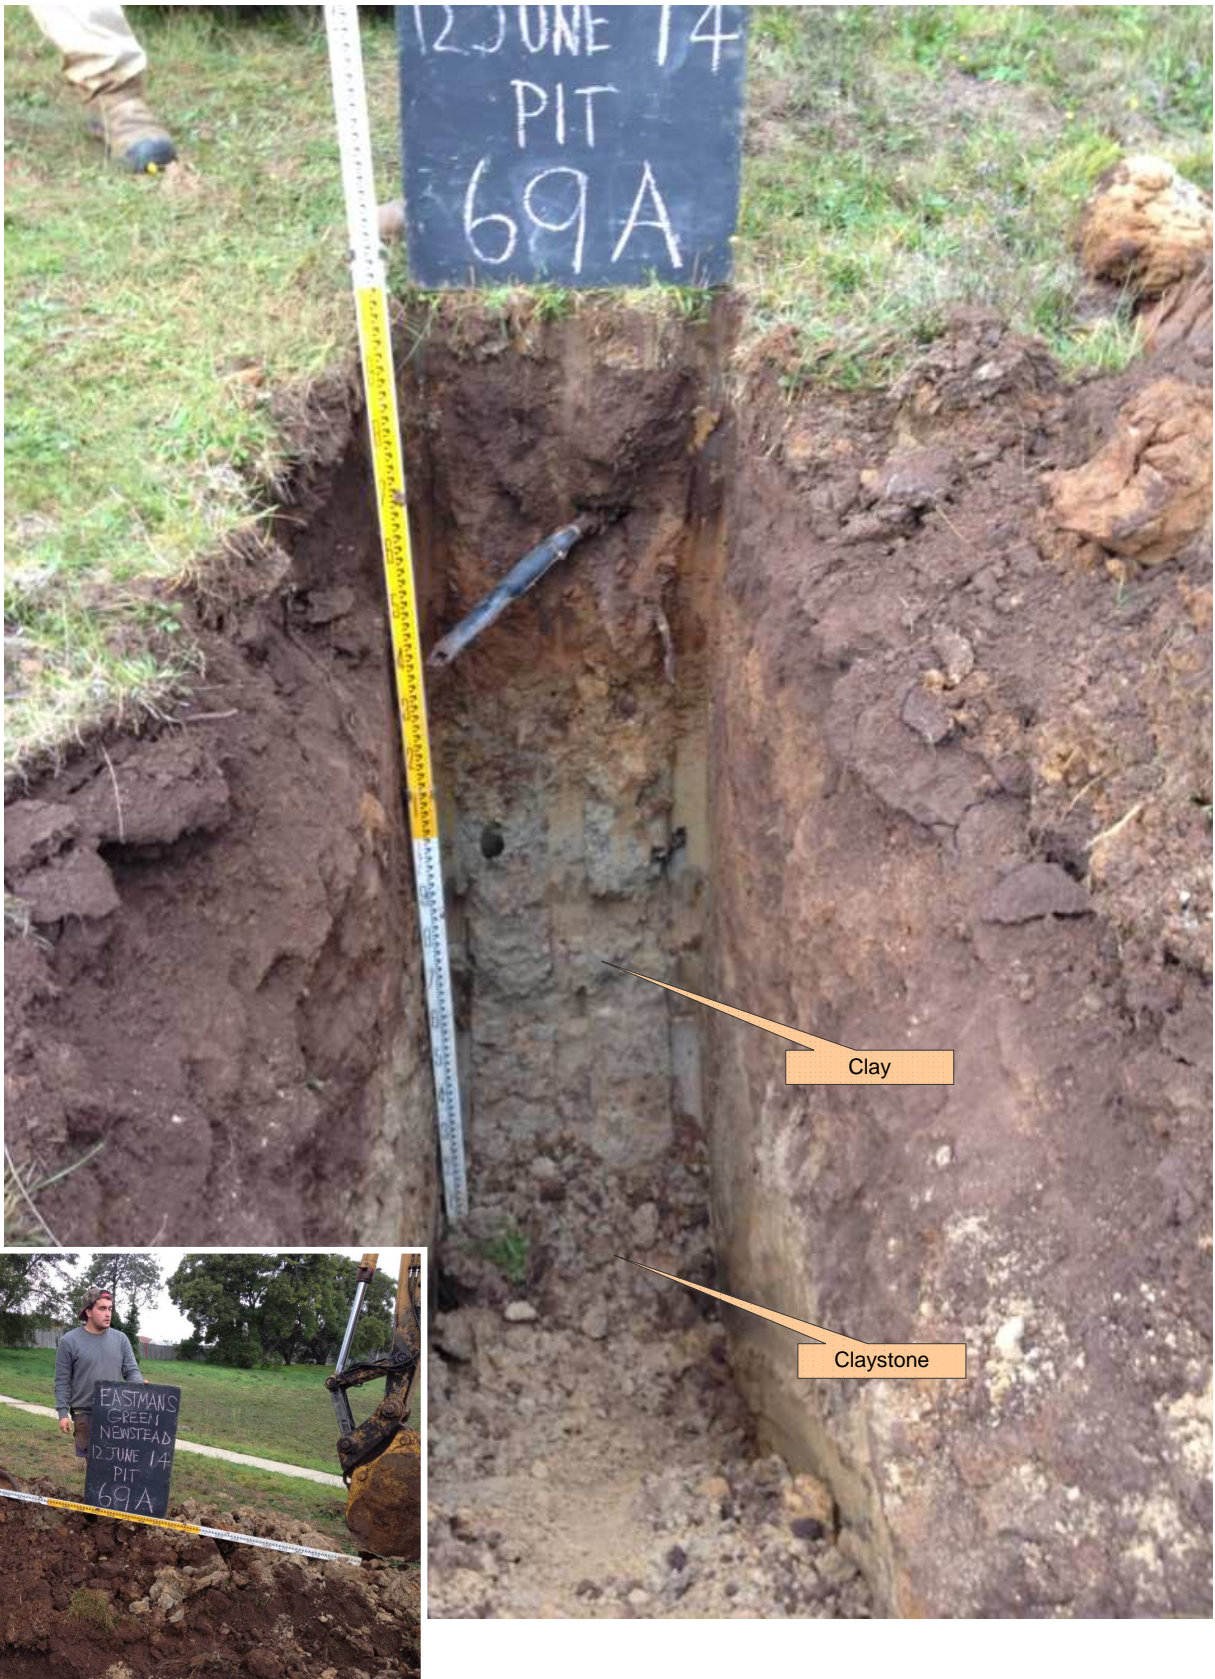
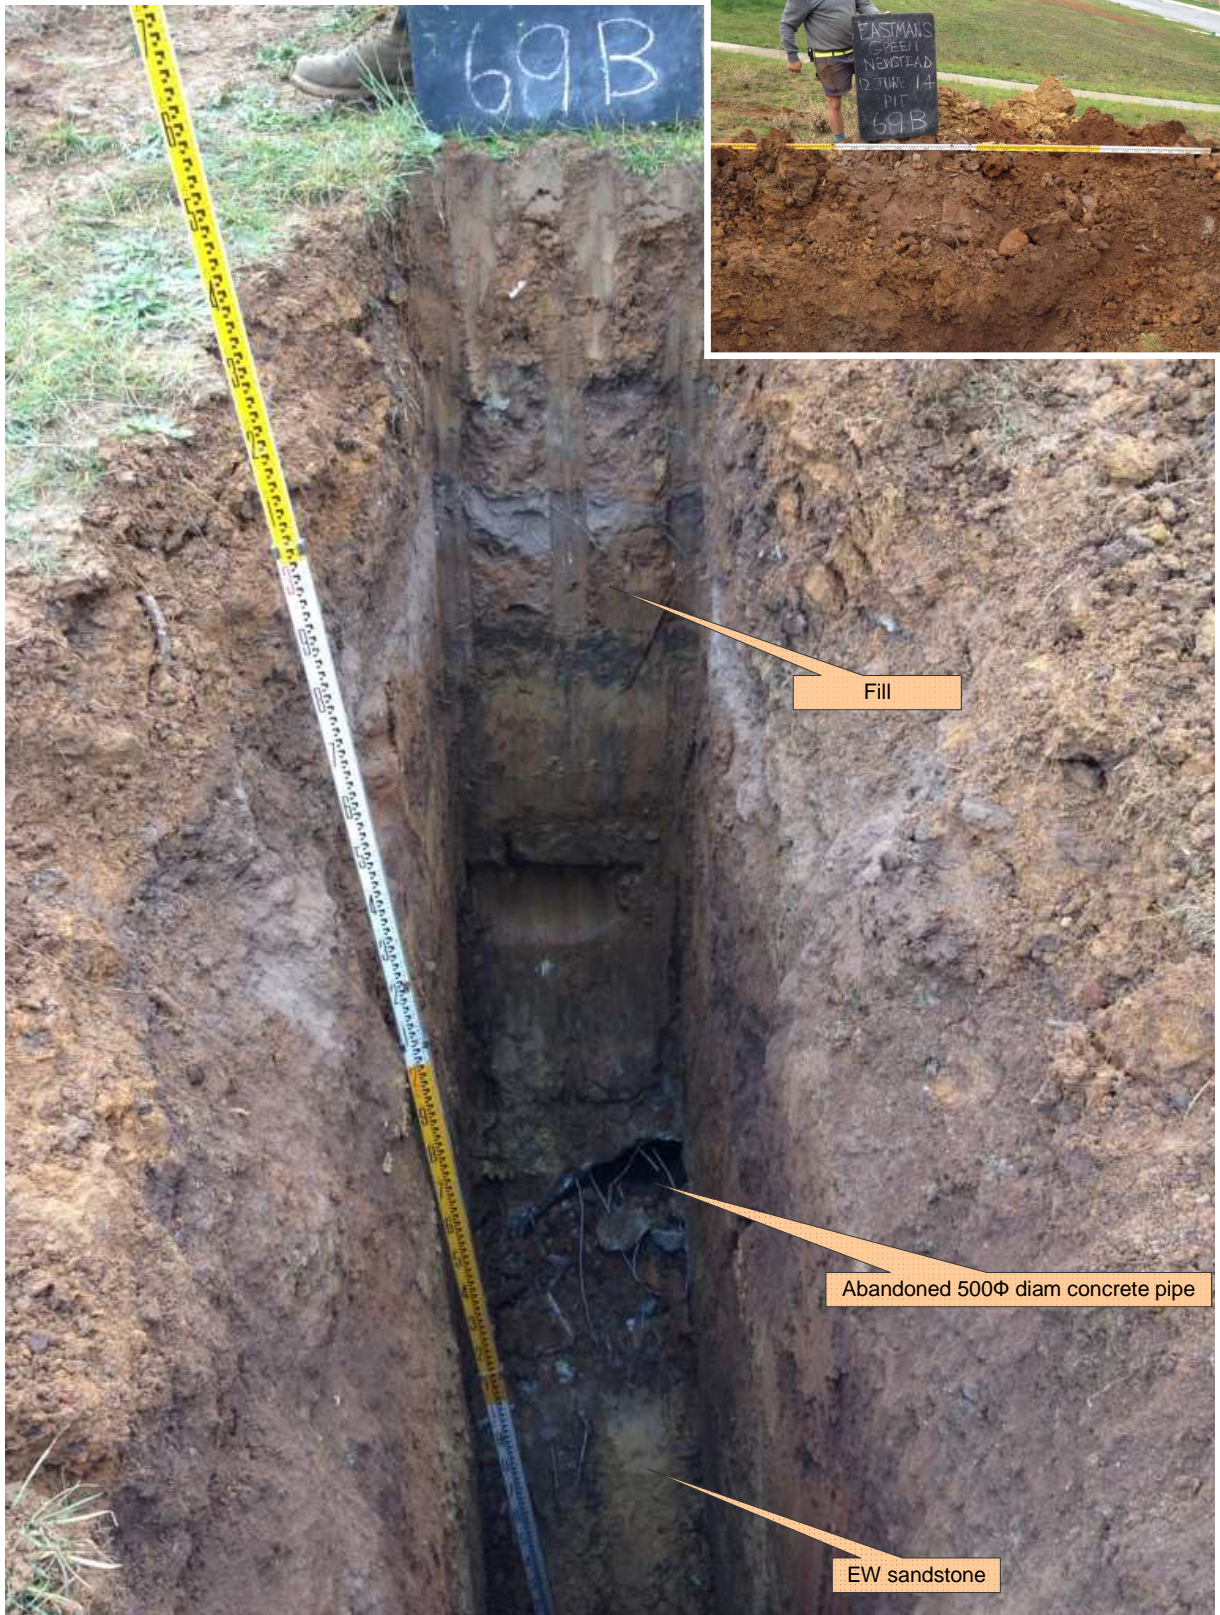
#### **Site and test pit photographs**

| <b>Subsurface conditions</b> | Clay and claystone in pit 69A; disturbed ground in pit 69B on extremely weathered sandstone |
