**PROPOSED ACCESS ROAD
RIFLE RANGE ROAD TO MARIA POINT
SOUTHEAST TASMANIA**

GEOTECHNICAL REPORT

Cromer, W. C. (2014). *Geotechnical report for a proposed access road, Rifle Range Road to Maria Point, southeast Tasmania*. Unpublished report for Maria Point Pty Ltd by William C. Cromer Pty. Ltd., 14 August 2014; 84 pages.

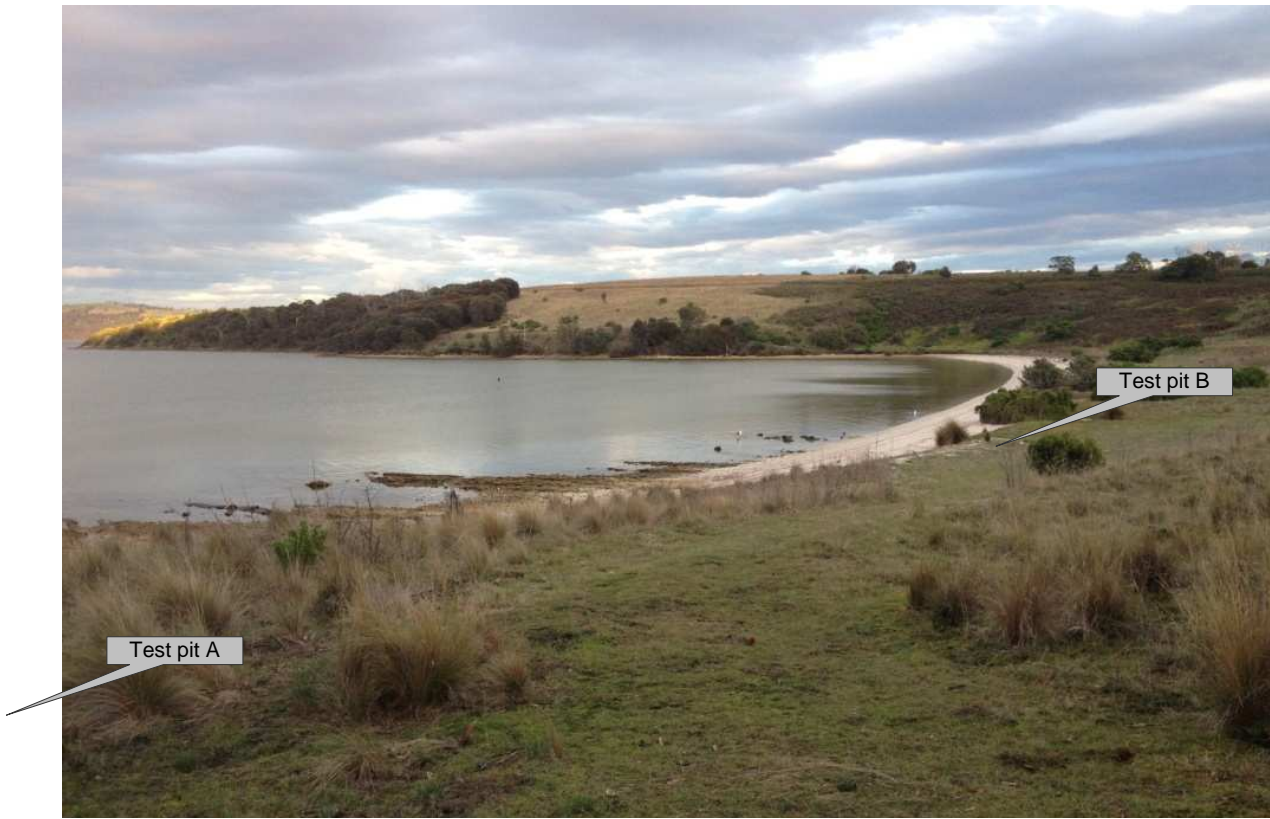
Plate 1 (above). View west across the western corner of Mortimer Bay towards test pit B.

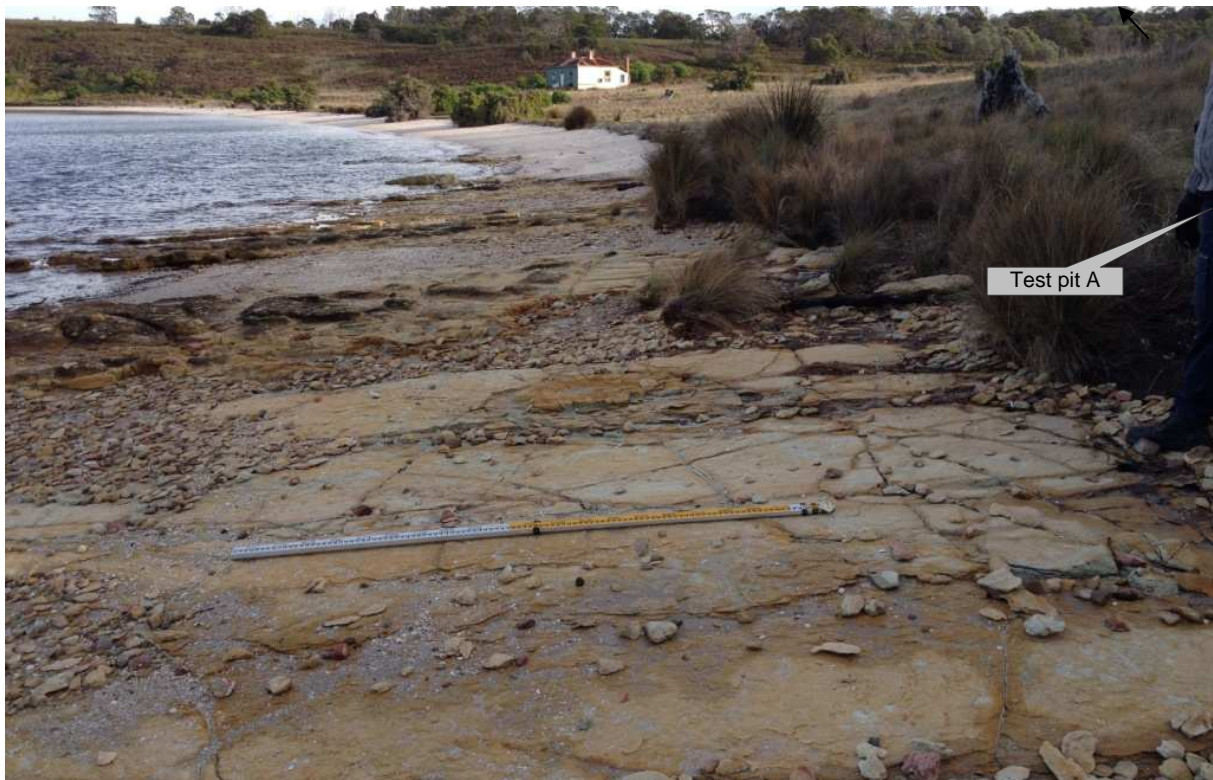
Plate 2 (below). View west from near test pit A over a shore platform of Permian-age siltstones dipping WSW at about 8° . The rocks form the bedrock of the Maria Point peninsula, and are generally slightly weathered, moderately fractured, and high strength.

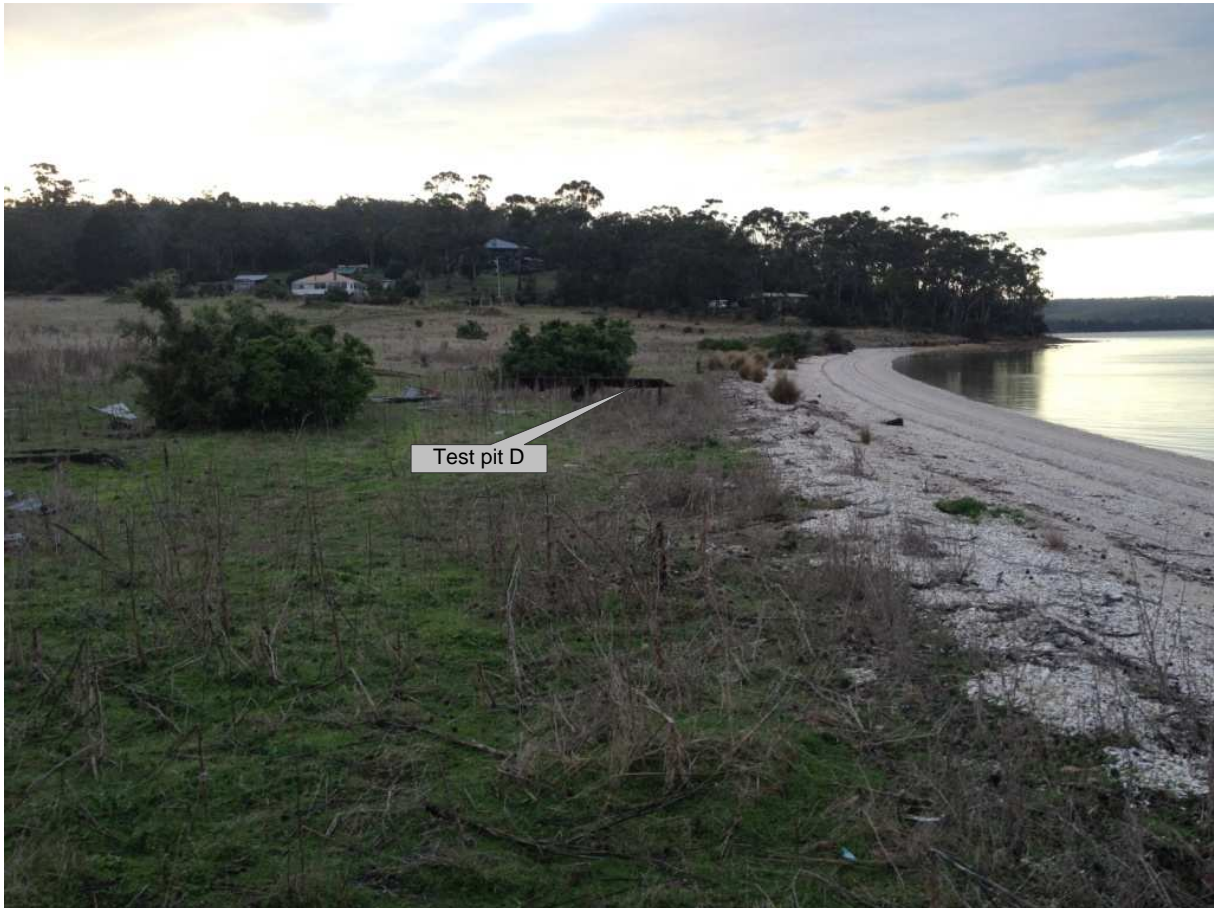
Plate 3 (above). View east from near test pit D. The low-lying ground about 1m AHD is underlain by about 100150 1.5m of aeolian and beach sand overlying estuarine clay. The sands contain in-situ shell lenses and horizons, and a water table is present at about mean sea level.

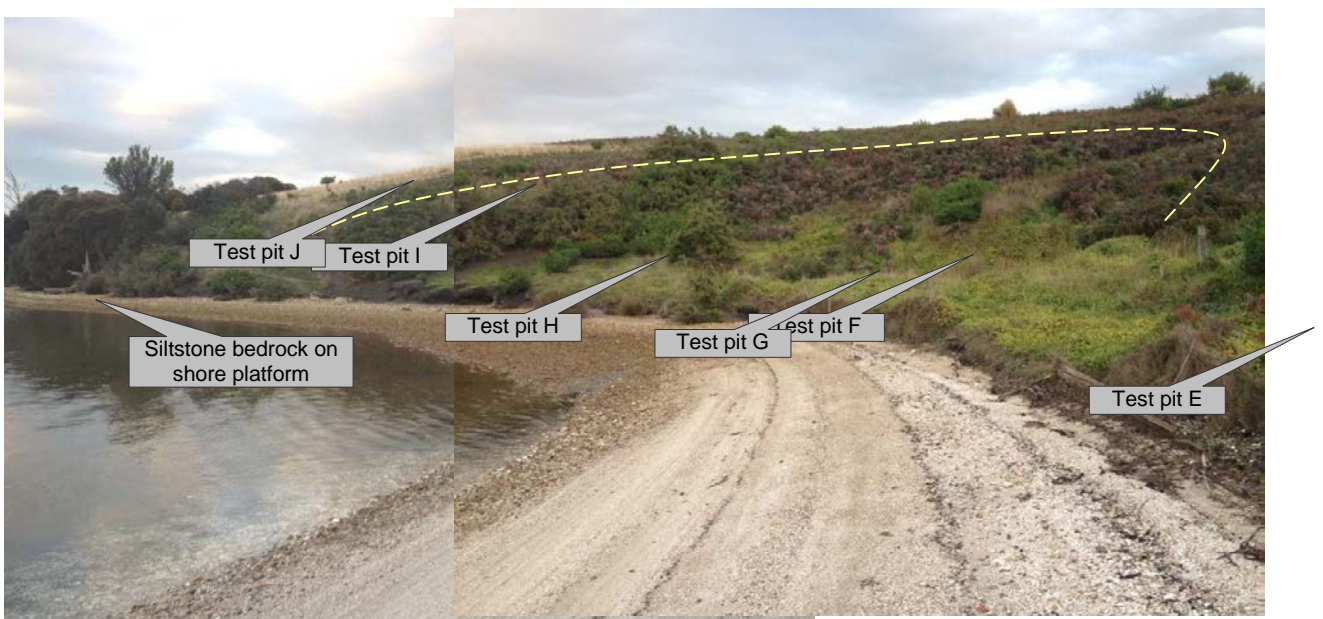
Plate 4 (below). View east from near test pit E towards steeper ground composed of aeolian sand and silty sand probably locally up to 2 – 3m thick, overlying Permian-age siltstone bedrock. The yellow dashed line is the (very approximate) outline of a probable shallow translational landslide in aeolian sand and silty sand.

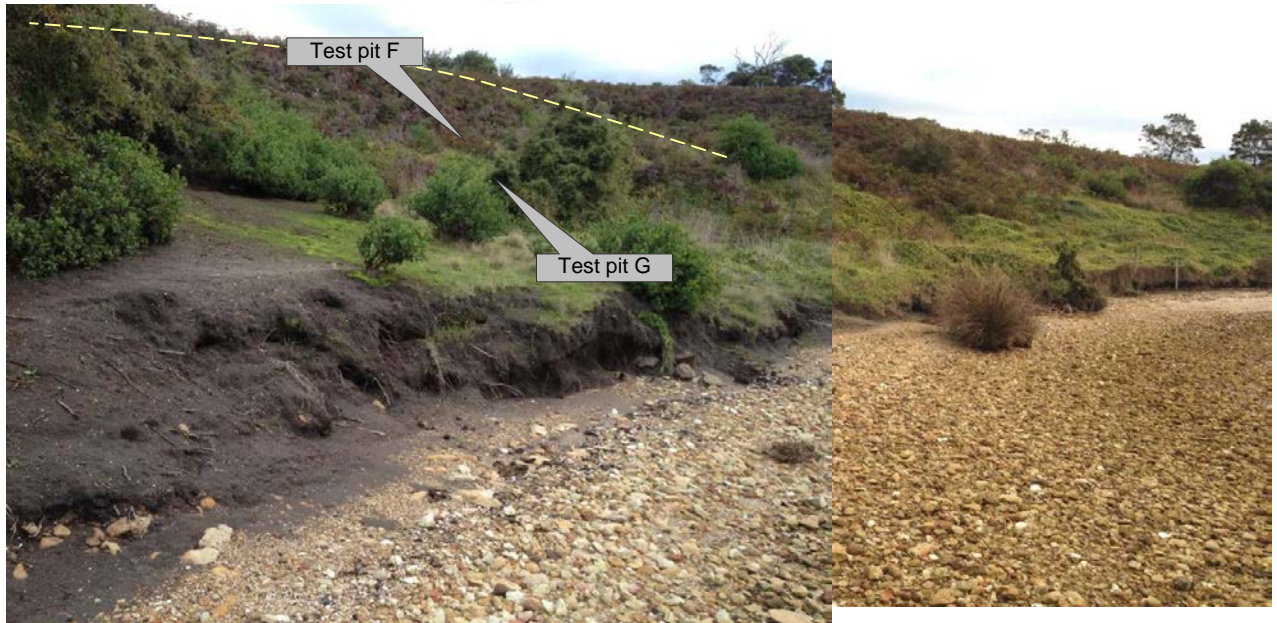
Plate 5 (above). View north towards test pits F and G. Siltstone bedrock was present in the base of test pit F at 2m, and beach shingle similar to that in the foreground was exposed in test pit G at 1.6m. The yellow dashed line is the (very approximate) northeastern limit of a probable shallow translational landslide in aeolian sand and silty sand. The dark-coloured silty sand soil is (a) probably moving downslope very slowly, and (b), is being removed at about the same rate by marine erosion.

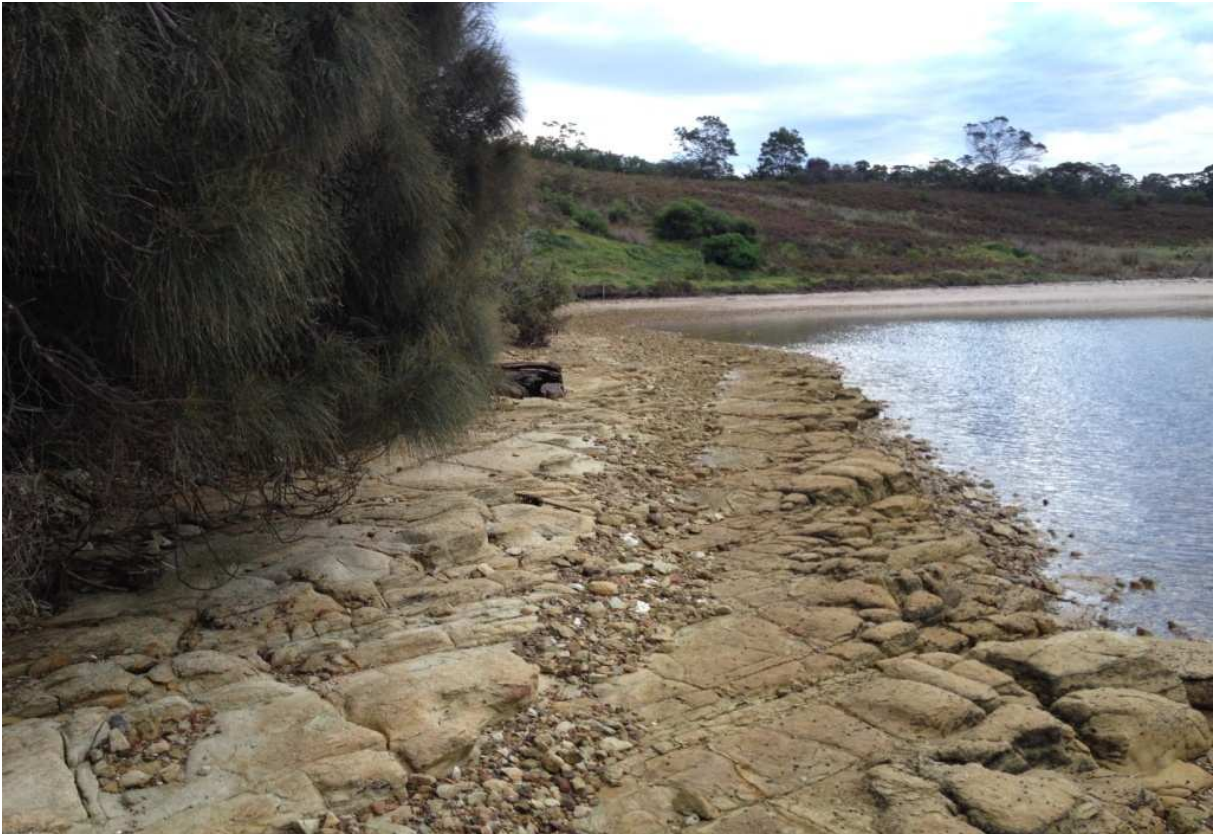
Plate 7 (above). View N showing subhorizontal Permian-age siltstones and sandstones dipping WSW – a similar attitude to the same rocks exposed near test pit A.

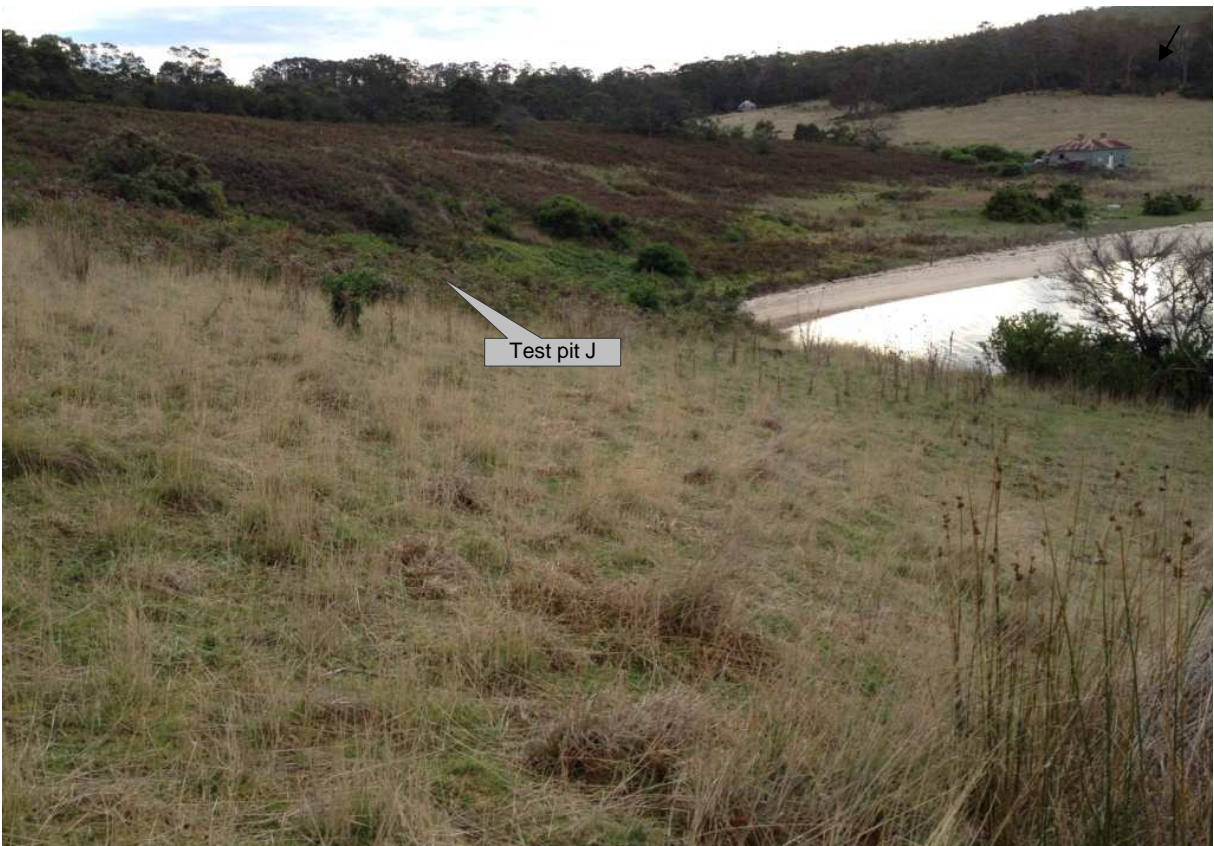
Plate 8 (below). View NNE towards test pit J. The hillside shown here is composed of Quaternary-age colluvial deposits of silty gravelly clay and clayey sand up to about 2m thick overlying Permian-age siltstone.

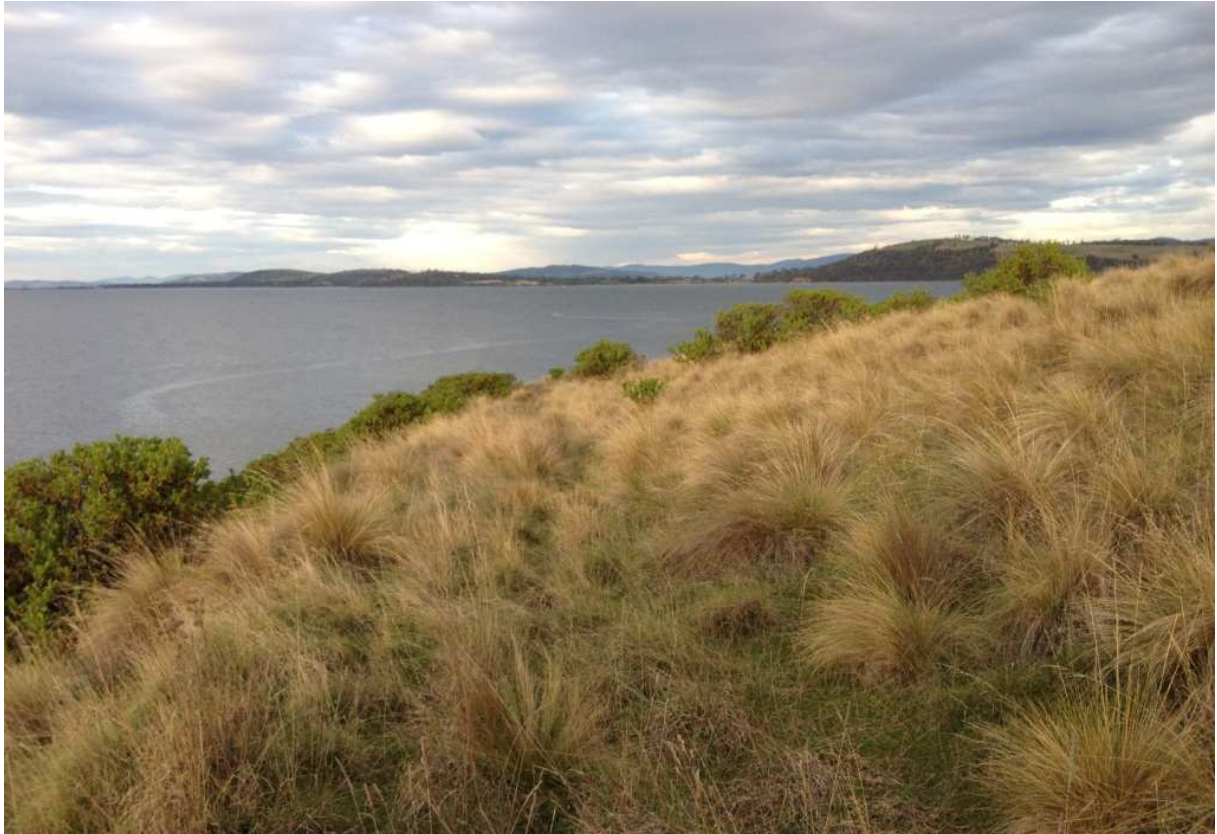
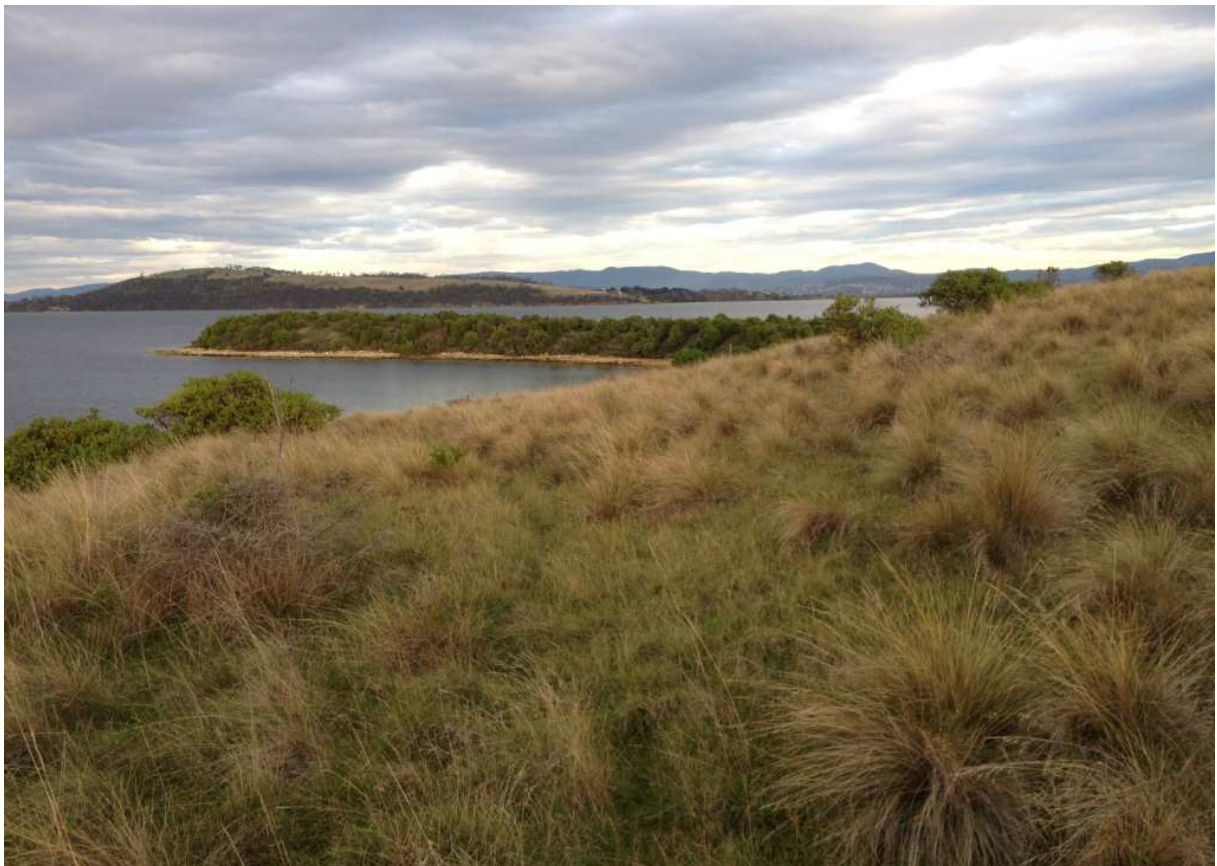
Plates 9 (above) and 10 (below). Views SSW towards Maria Point, along an abandoned, formed access track, near test pits P and Q. Fill up to about 1.2m thick (in test pits P and Q) forms the outer eastern side of the track. The undisturbed ground comprises silty gravelly sand soils up to a metre thick, over subhorizontal Permian-age siltstone.

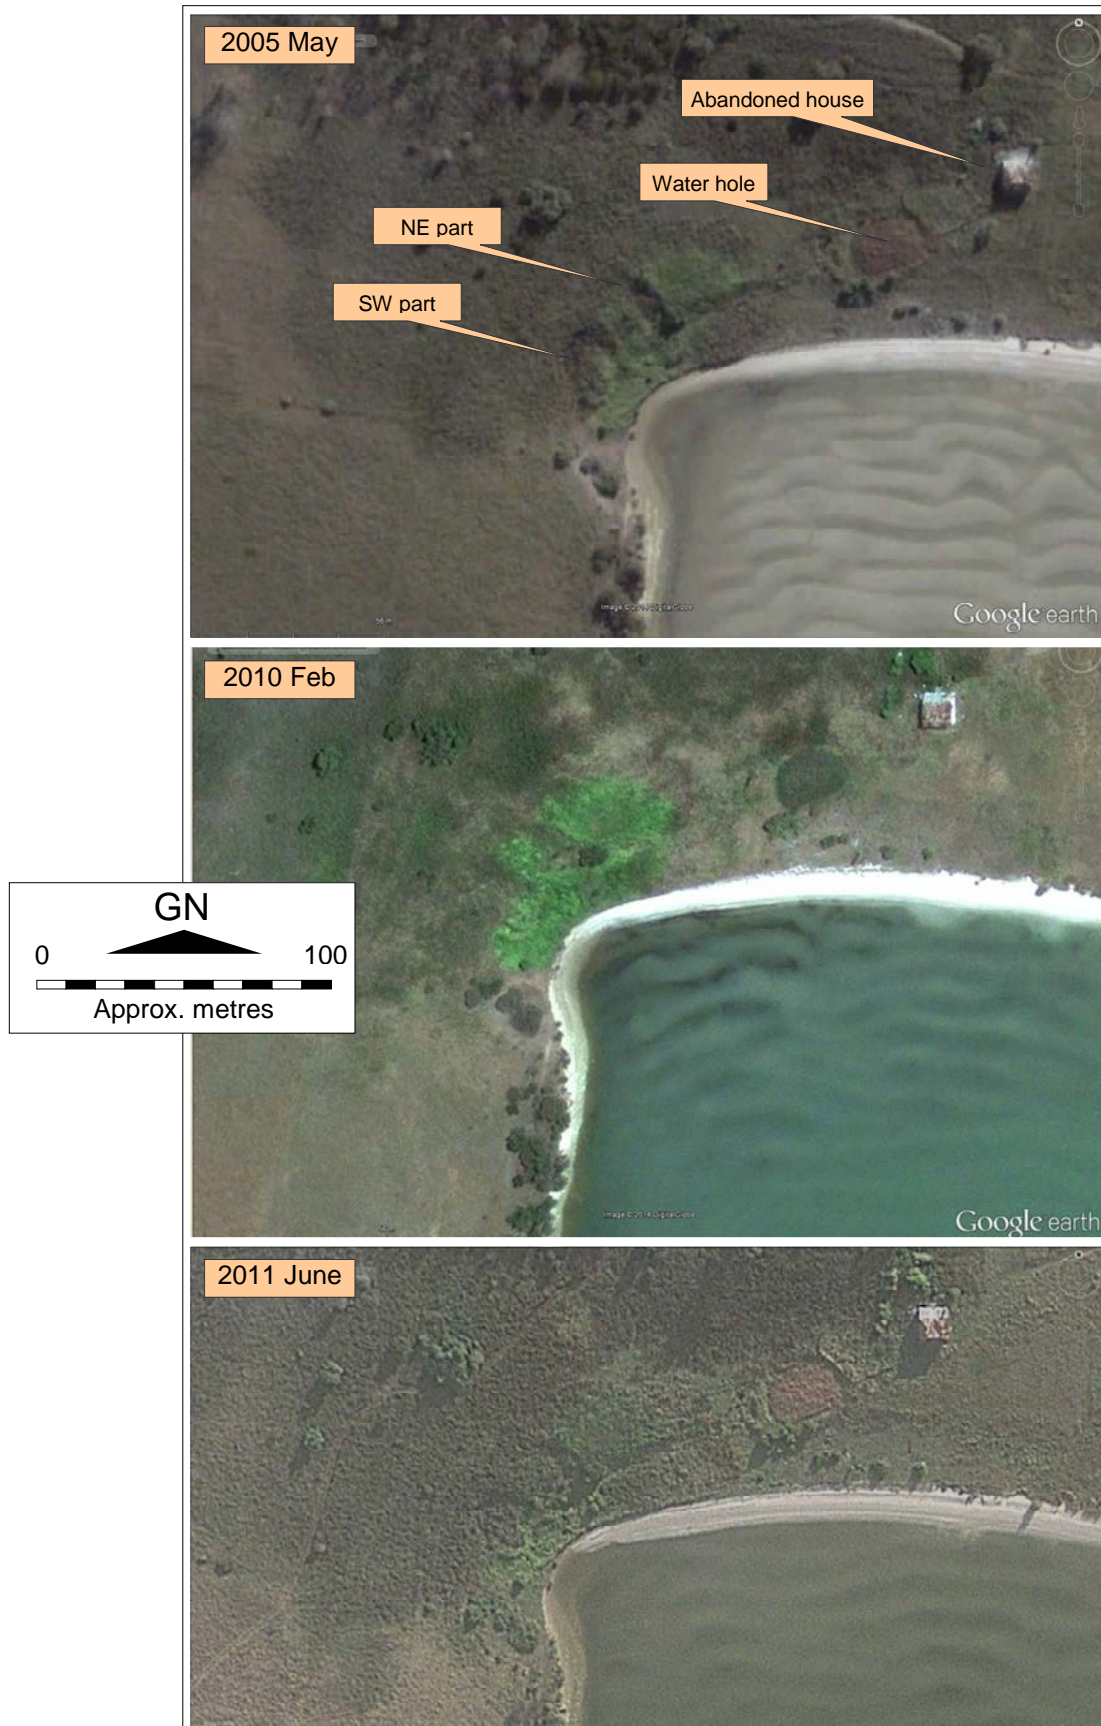
Figure 8.3 Historical satellite imagery of the landslide feature in the western corner of Mortimer Bay. The 2005 and 2011 images suggest it may be two smaller features. These images also show what appears to be a track leading from the northeasterly of the two features, towards the water hole and abandoned house. Source: Google Earth

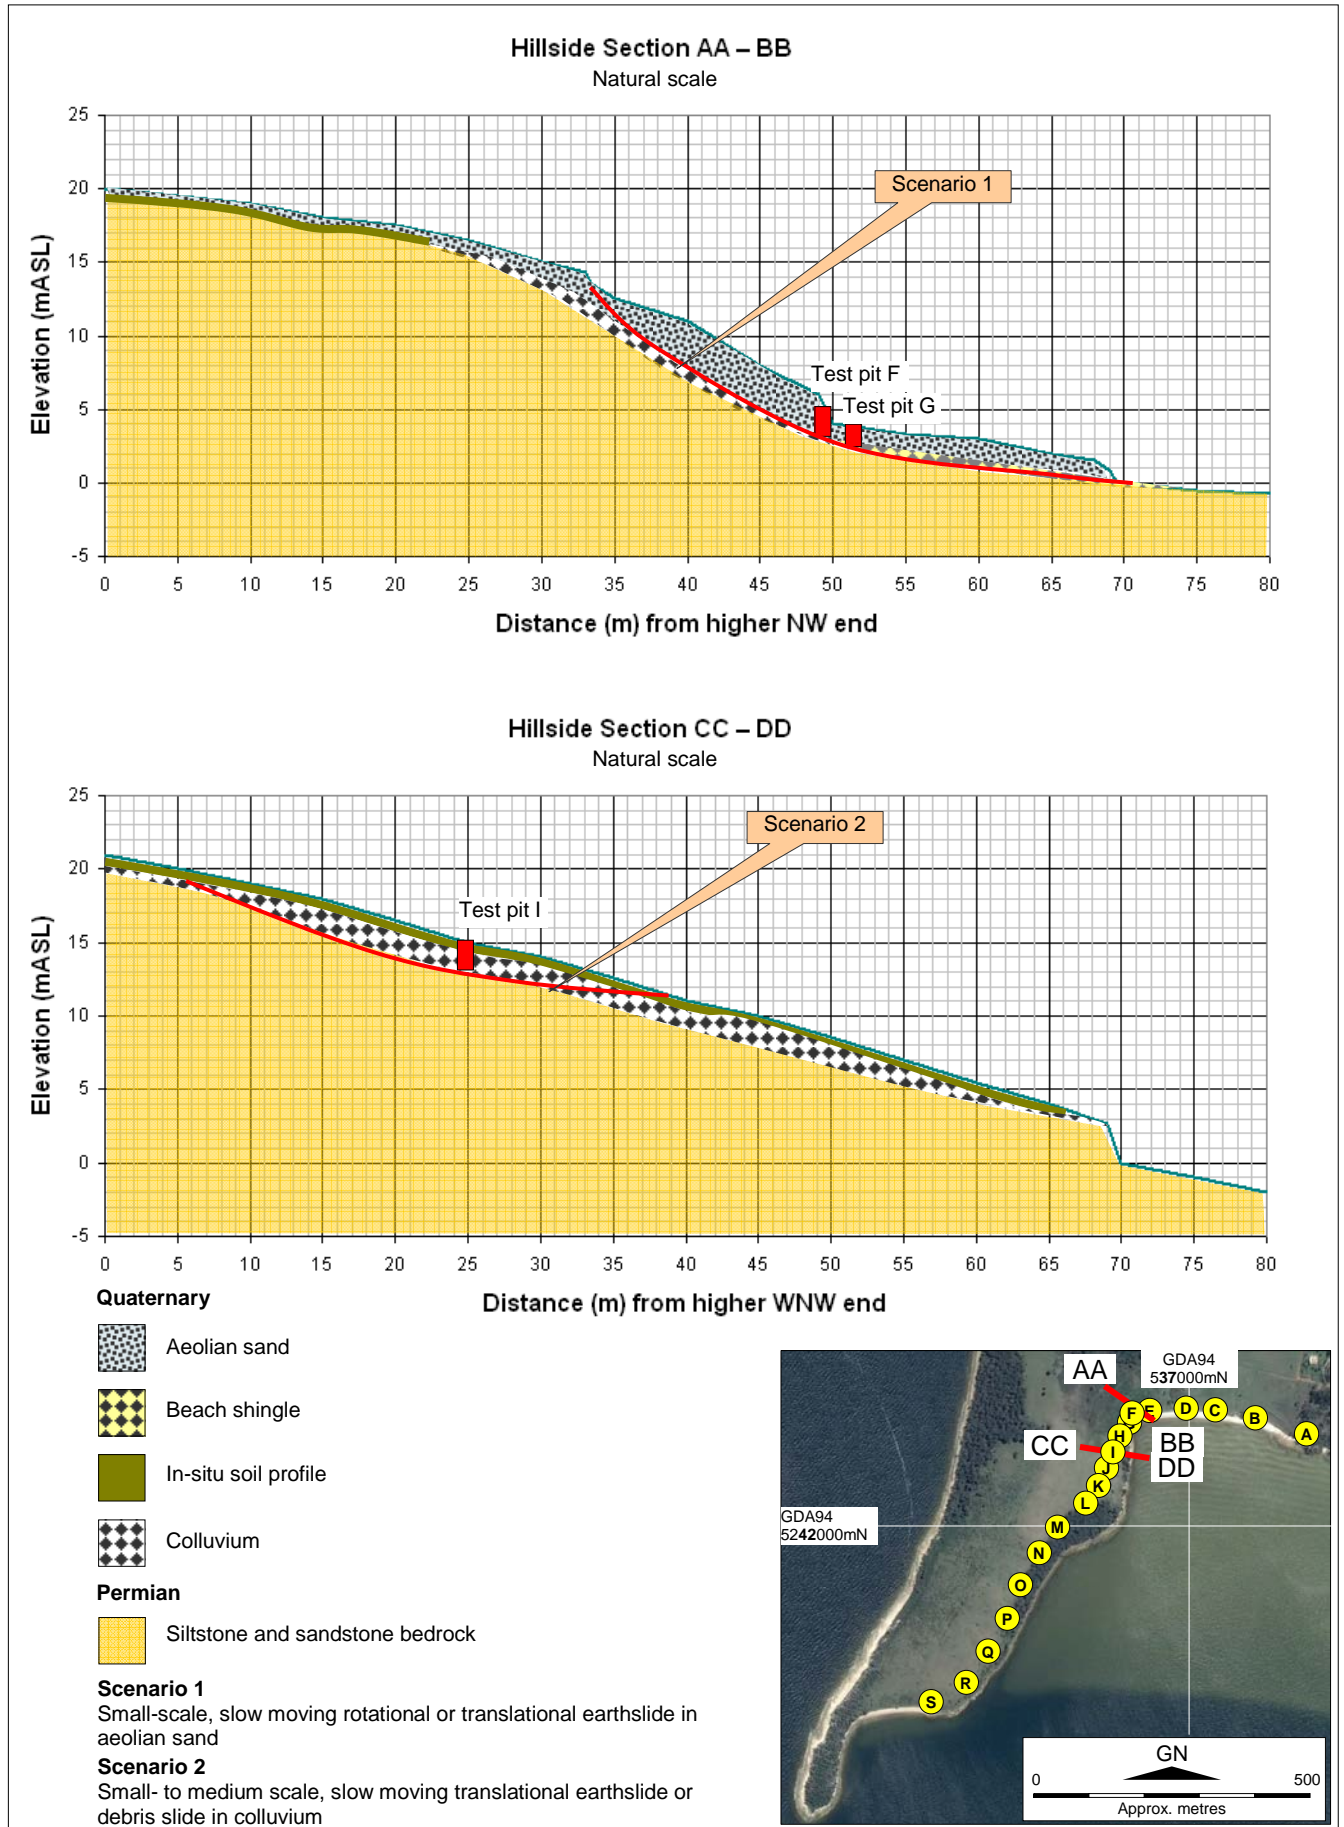
Figure 8.4 Landslide scenarios in Section 2 for Landslide Risk Management

Between test pits E and G, appropriate culverting shall be employed at the low point in the access road to manage surface and shallow subsurface drainage, which should then discharge in pipework to the lower edge of the study strip. This same culvert could be sized and designed to collect runoff from the southern portion of Section 2¹⁶.
