**PROPOSED ACCESS ROAD
RIFLE RANGE ROAD TO MARIA POINT
SOUTHEAST TASMANIA**

GEOTECHNICAL REPORT

Cromer, W. C. (2014). *Geotechnical report for a proposed access road, Rifle Range Road to Maria Point, southeast Tasmania*. Unpublished report for Maria Point Pty Ltd by William C. Cromer Pty. Ltd., 14 August 2014; 84 pages.

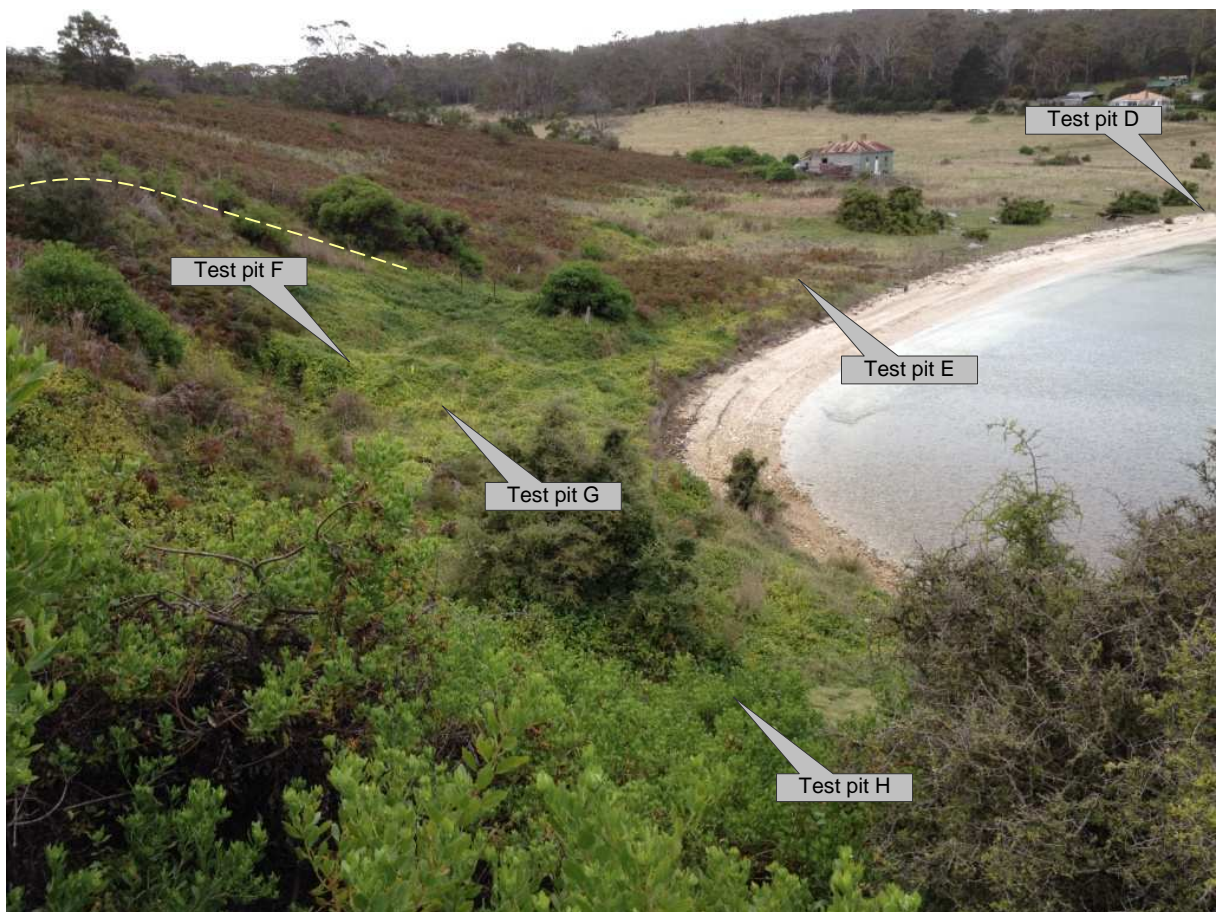
Plate 5 (above). View north towards test pits F and G. Siltstone bedrock was present in the base of test pit F at 2m, and beach shingle similar to that in the foreground was exposed in test pit G at 1.6m. The yellow dashed line is the (very approximate) northeastern limit of a probable shallow translational landslide in aeolian sand and silty sand. The dark-coloured silty sand soil is (a) probably moving downslope very slowly, and (b), is being removed at about the same rate by marine erosion.

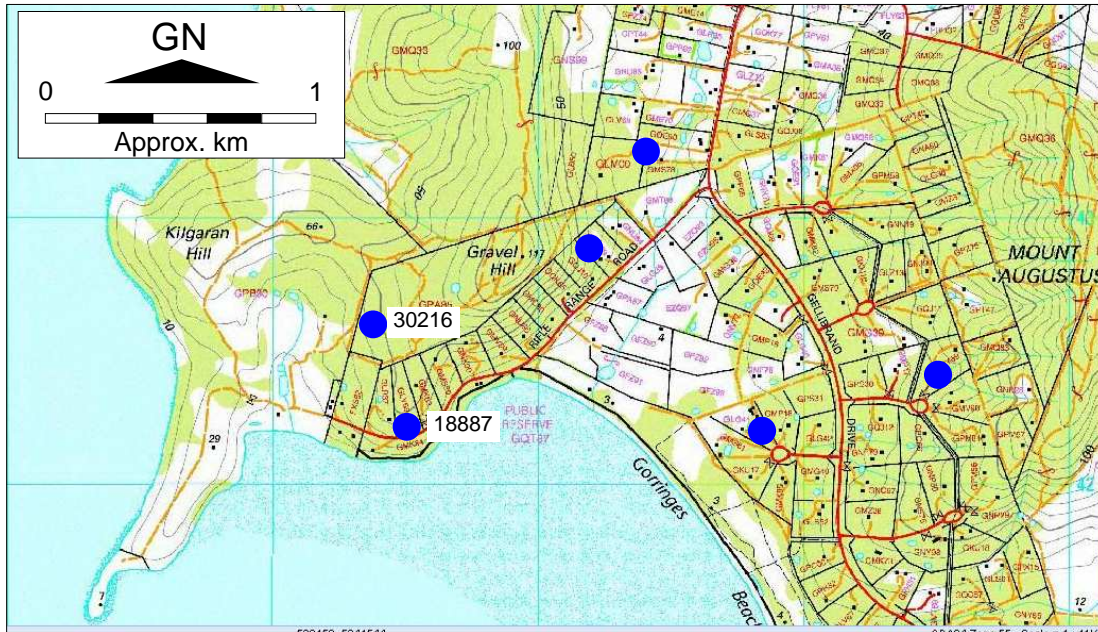
Permanent groundwater is known to be present under unconfined conditions in fractured bedrock types in the district (Figure 7.2). The groundwater is recharged by infiltrating rain and at intermediate scale discharges to Mortimer Bay.

Figure 7.2 Recorded water bores (blue circles) in the vicinity of the study strip. The two closest ones are bore 18887 (drilled 1985; 61m deep into Permian rocks; water table at 12m; initial yield 0.37L/sec), and bore 30216 (abandoned; drilled 91m into Permian rocks in 2003).

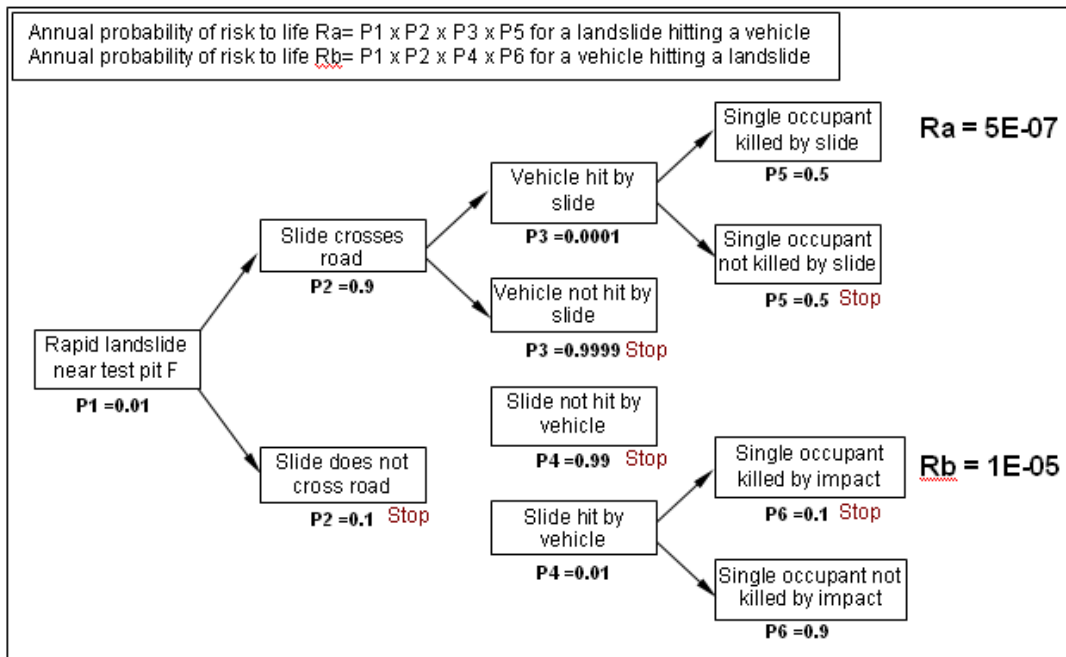
Scenarios 1 and 2 present acceptably low risks to life. The highest risk is related to Scenario 1. Figure 8.6 is an event tree which assesses the risks to life for an occupant of a vehicle travelling the access road, and either being hit by the landslide, or hitting the landslide.

Figure 8.6 Event tree for risk to life for an occupant of a vehicle travelling the access road and being hit by a rapid landslide (risk R_a) or hitting a landslide (risk R_b). The latter is the higher of the two, but both are acceptably low.

Reducing the frequency of the Scenario 1 risk is achieved by the recommended drainage and retaining wall controls.
