Attachment 12

Quantitative Slope Stability Assessment

Using the computer application *Galena*TM: *Slope Stability Analysis System*, Version 5.1
(Clover Technology, 2006)

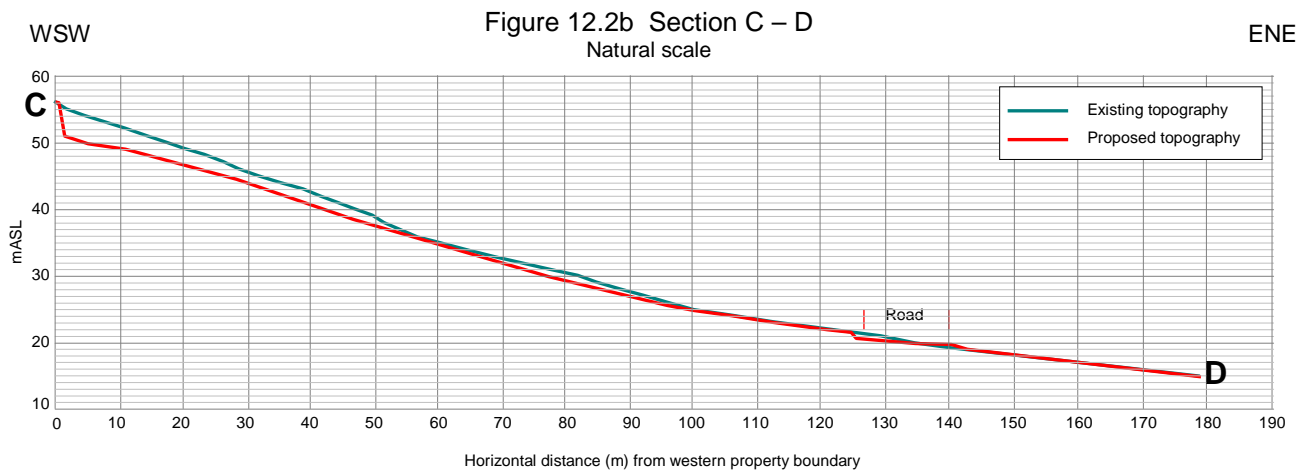
Figures 12.2a, b and c Cross sections A – B, C – D and E – F at natural scale
 Proposed topography from Attachment 8

Figure 12.1 is reproduced from Attachment 7 and includes the locations of three section lines: A – B, C – D and E – F from the western property boundary down the slope to the east. Figures 12.2a, b and c are cross sections of the lines.
